**HISTORIC PRESERVATION REVIEW BOARD
STAFF REPORT AND RECOMMENDATION**

Landmark/District:	Capitol Hill Historic District	<input checked="" type="checkbox"/> Agenda
Address:	528 4th Street, S. E.	<input type="checkbox"/> Consent
ANC:	6B	<input checked="" type="checkbox"/> Concept
		<input checked="" type="checkbox"/> Alteration
Meeting Date:	February 24, 2022	<input type="checkbox"/> New Construction
Case Number:	22-145	<input type="checkbox"/> Demolition
		<input type="checkbox"/> Subdivision

Applicants Sarah Struble and Matthew Handverger, with plans prepared by Beth N. Davis, seek concept review for a cladding material change at a property located in the Capitol Hill Historic District.

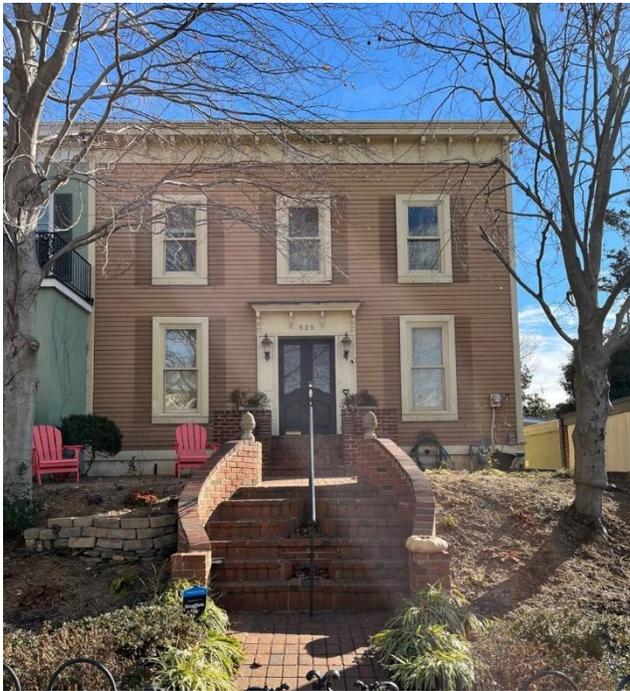
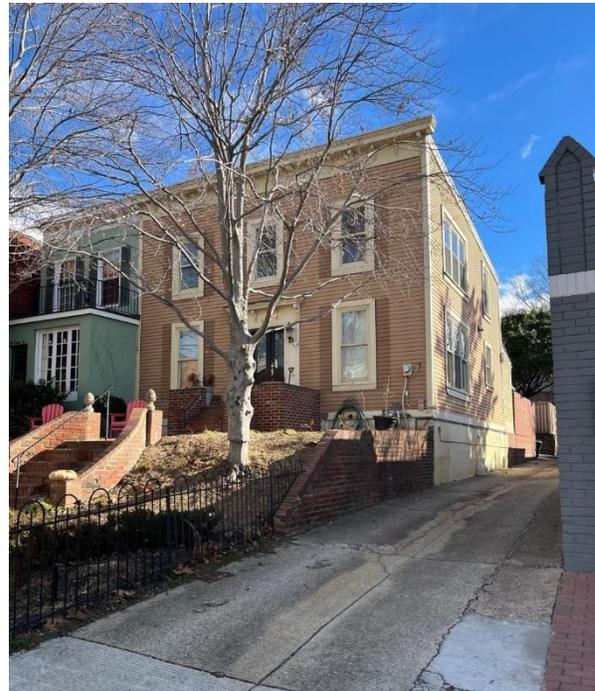
528 4th Street S.E. is a semi-detached two-story frame dwelling that appears in the 1874 Faehztz and Pratt Real Estate Directory. The three-bay wide home is on an elevated berm adjacent to a through-block alley.

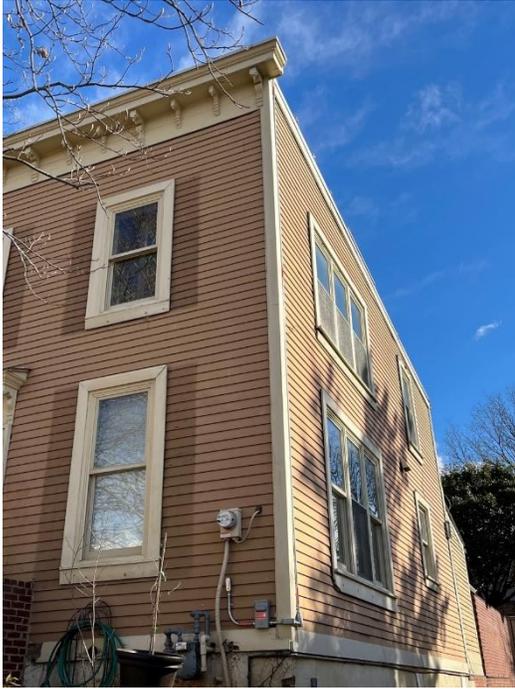
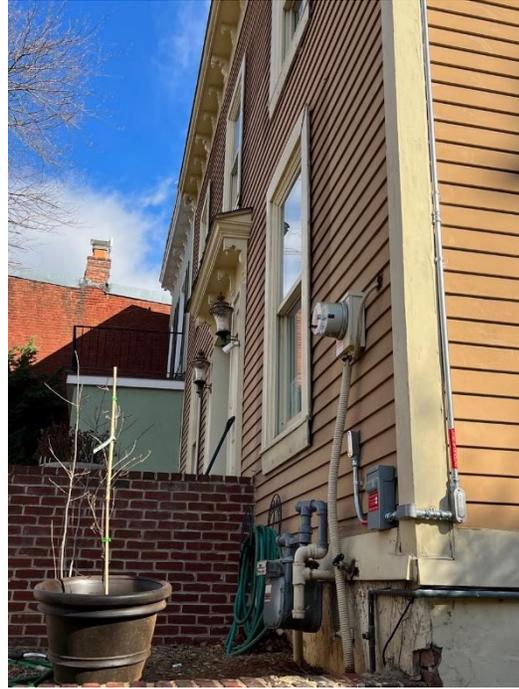
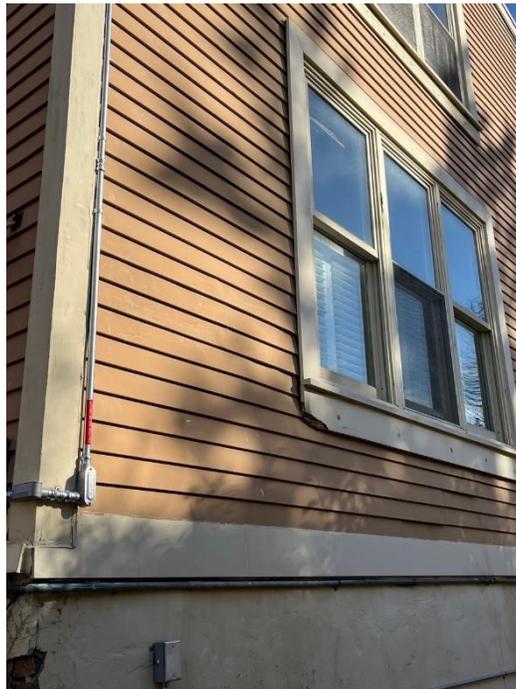
The existing siding boards are proposed to be removed and replaced by a seven-inch smooth Hardie board siding on the three exposed elevations. The window trim would be a four-inch Hardie board. And the exterior framing at the outer corners, fascia, and water table would be a six-inch Hardie board. The existing cornice and door surround trim are not proposed for replacement.

Based on the age and style of this building, it most likely had wood siding originally. The size of the building, scale of the trim, and refined door surround indicates this would have been siding with a narrower reveal than some of the more humble buildings of the same age that had larger rough-hewn siding boards.

Fiber-cement board siding does not match the shadow lines, depth, and natural irregularity of natural wood siding and trim material. The difference is discernable even from the sidewalk at a distance and thus has an impact on the overall experience of the historic district. While fiber cement board siding has regularly been found appropriate on rear elevations and rear additions, it has not been found compatible for use on the front or visible side elevations of contributing historic buildings.
